Septodont Case Studies *Collection*

No. 06 - October 2013

Racegel : Gel Retraction Material

A four-year prospective study of the use of N'Durance[®] composite, a nano-hybrid resin

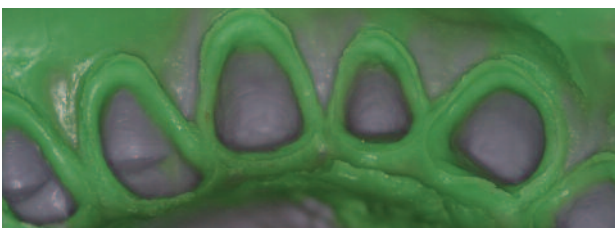
Fig. 1: An ideal indirect restoration impression. The material is void-free, clear of debris, and exhibits clean capture of the preparation margins.

In fixed prosthodontics, clinically acceptable impressions are an absolute necessity (*Fig. 1*). The laboratory fabricating the restoration is limited in its final quality by the quality of the incoming impression. The unfortunate reality is that most impressions are clinically unacceptable.¹

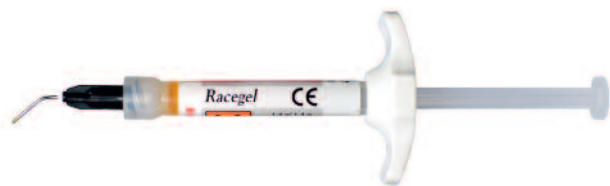
Fig. 2: Racegel is dispensed from a single-barrel syringe. It is colored to allow easy visualization in placement and to aid in verification of its removal.

This article will discuss impression techniques using a new gel retraction and hemostatic aid called Racegel (*Fig. 2*).

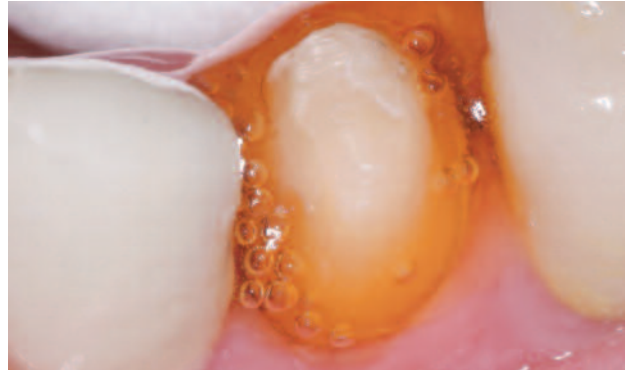
Fig. 3: In cases with a thinner gingival biotype, Racegel can be used as the sole source of hemostasis and tissue retraction.

This posterior crown is a common example of a low crest and deep sulcus restorative situation (*Fig. 3*). Because of the sulcus depth, often one cord is not adequate to fully displace the tissue and obtain a quality impression. Instead of traumatizing the tissue with two cords, one small cord was placed and then Racegel was injected into the sulcus. This provided the necessary retraction and hemostasis.

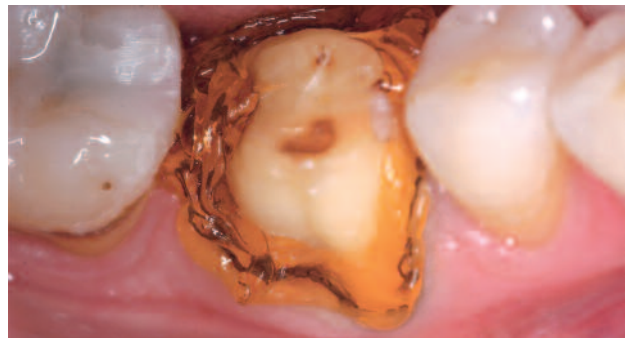
Fig. 4: In this case Racegel was being used in conjunction with a packed cord to control gingival bleeding and to aid in tissue retraction.

All-ceramic preparation margin designs will often be at the level of the gingival margin (*Fig. 4*). The premolar seen in this figure, which has a normal gingival biotype, can be readied for impression with Racegel as the sole source of retraction.

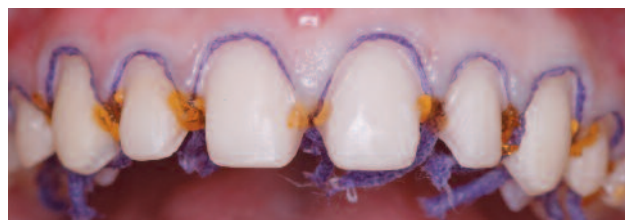
Fig. 5: In this multi-unit case, Racegel was used in conjunction with cord to control interproximal bleeding.

Preoperatively, this case had generalized interproximal decay and decalcification (*Fig. 5*), which resulted in residual interproximal inflammation and bleeding at the preparation visit. Dry cords were placed in the sulcus, and Racegel was placed on the bleeding areas. By controlling the tissue and obtaining a high-quality impression (*Fig. 6*), properly fitting restorations were created that allowed optimal health postoperatively (*Fig. 7*).

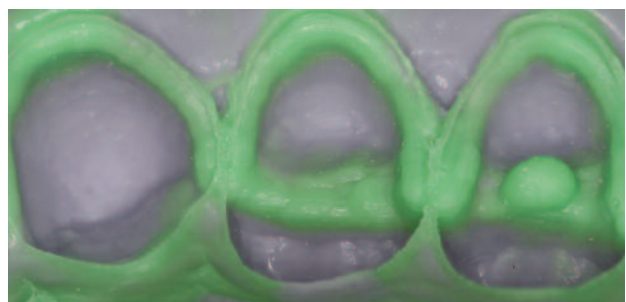
Fig. 6: The final impression from the case.

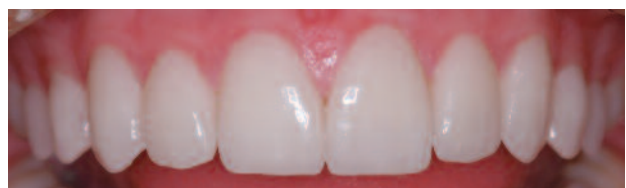
Fig. 7: The final lithium-disilicate veneer restorations. Note the healthy tissue response associated with properly fitting restorations.

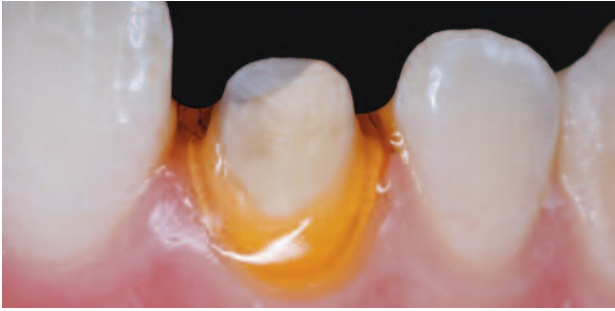
Fig. 8: An anterior crown preparation. This tooth had an average gingival biotype, which allowed the use of Racegel as the sole source of gingival retraction.

This anterior crown preparation was associated with a thin gingival biotype and low bone crest. To keep tissue trauma to a minimum, Racegel was used as the only source of retraction (**Fig. 8**). After 2 minutes of setting, the material was easily rinsed away, leaving a clearly exposed margin (**Fig. 9**). The resulting impression had crisp 360° margins and captured past the margin end point (**Fig. 10**).

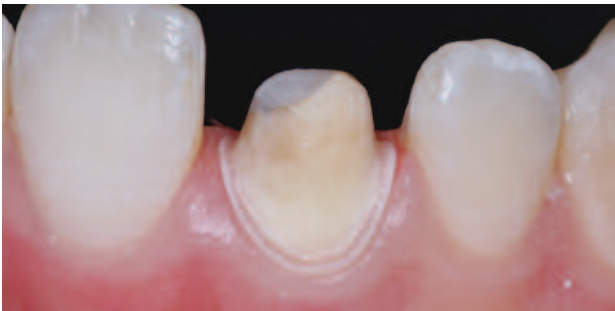
Fig. 9: The Racegel was rinsed away with no residue, leaving a dry, clearly exposed margin.

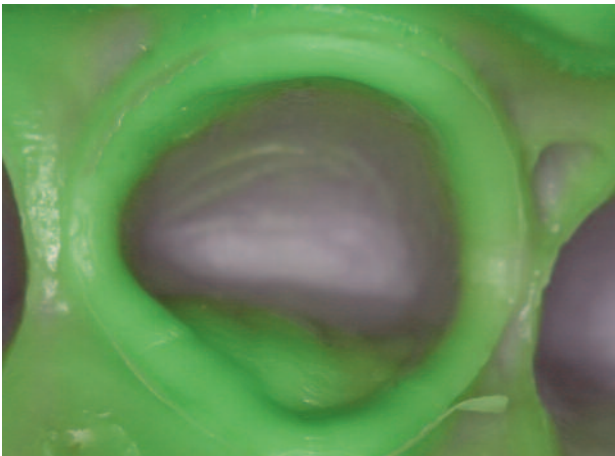
Fig. 10: The final impression. Note the 360° marginal capture.

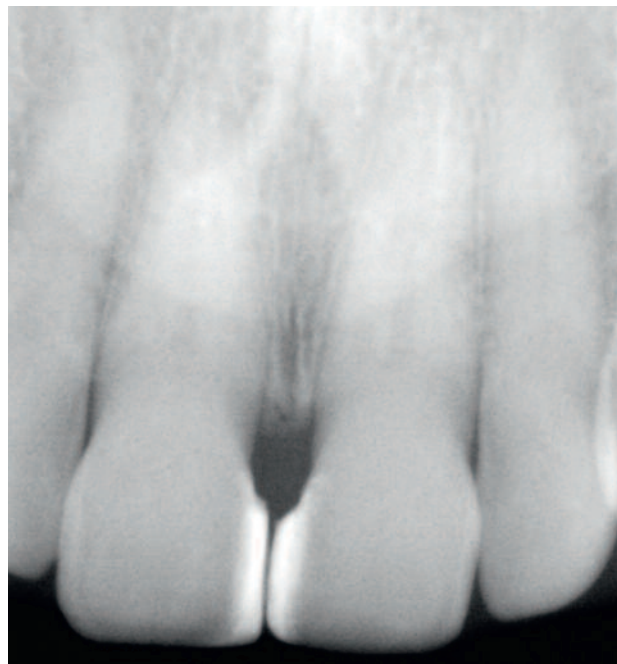
Fig. 1

The N'Durance® composite offers good handling characteristics, having a high viscosity and low feeling of stickiness during placement. In addition, it has a high opacity on radiographs, making it easy to differentiate it from tooth structure (*Fig. 1*).

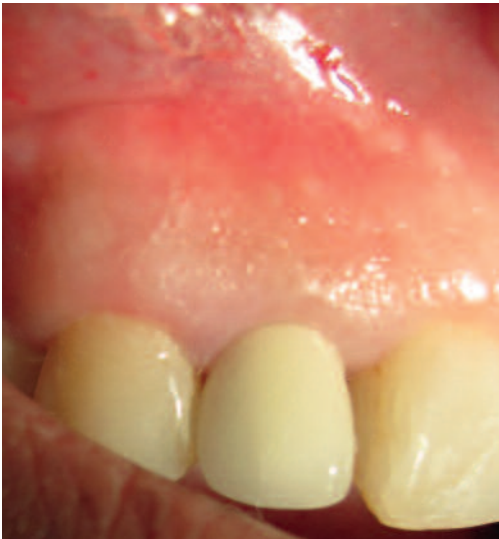
Fig. 1

We observed in the clinical examination that the tooth has a ceramic metal crown. No increase in the tissue volume was observed at the vestibular level (*Fig 1*), there is no sign of fistula, pain manifestation on palpation and vertical percussion.

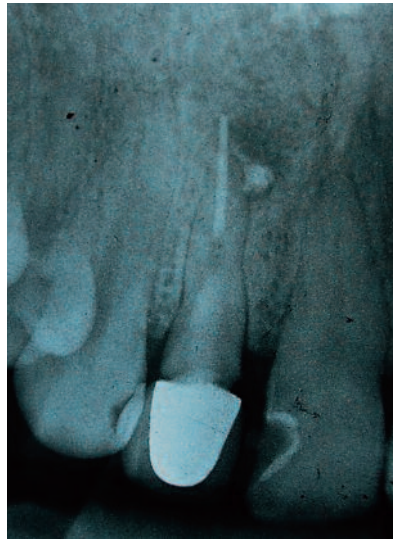
Fig. 2

The X-ray examination showed that the ceramic metal crown was not sealed at the cervical level, through the radiotransparency of the crown filling we noticed a fiber post, with absence of filling in the entire lumen of the canal prepared for the post, we also observed an over-obturation of approximately 3 mm and extravasation of the sealing cement, located in a radiotransparent area compatible with a chronic periapical process. (Fig 2)

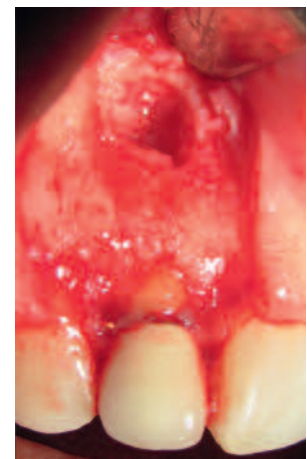
Fig. 4

curettage, the over-obtuated material and the surrounding granulomatous process was removed, and washed abundantly with saline solution to verify the removal of all the pathological tissue. The apicoectomy was performed with a fissure bur, creating as little bevel as possible and following the direction of the apical process. The apical chamber was prepared with a round bur following the direction of the root canal, at a 3 mm depth, it was thoroughly washed with saline solution and the cavity was dried with paper cones. (Fig 4)

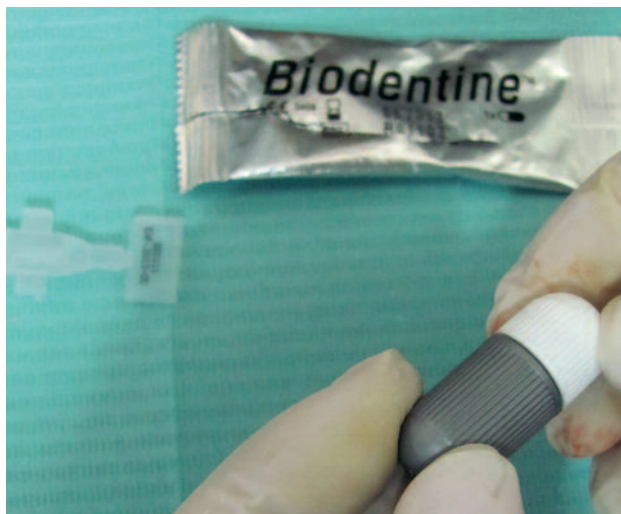
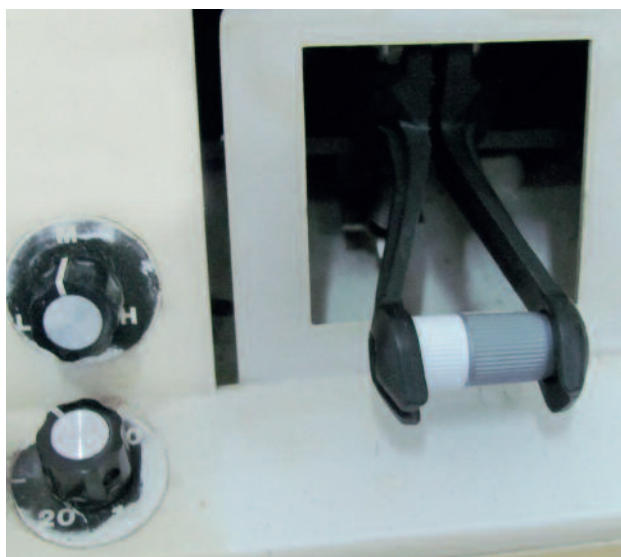
Septodont's Biodentine™, an active biosilicate-based retrograde obturation material was prepared according to the manufacturer's instructions, mixing 5 drops of the liquid (Aqueous calcium chloride and excipients solution) with the powder

(tricalcium silicate) for 30 seconds in the Henry Schein amalgamator Model: HS-1. (Fig 5, 6)

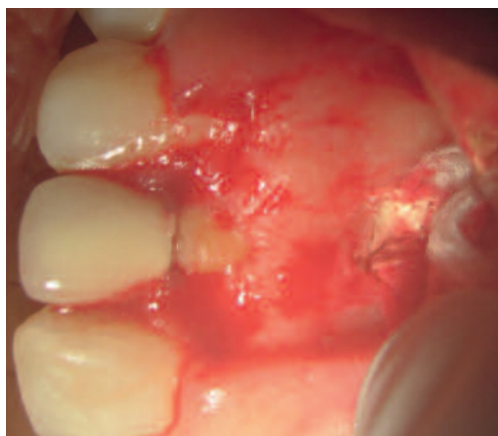
Fig. 7

We then placed the appropriate amount of material in the prepared cavity and condensed it, after 12 minutes, completely isolated from fluids, according to the manufacturer's recommendation (Fig 7), the excess was removed. (Fig 8)

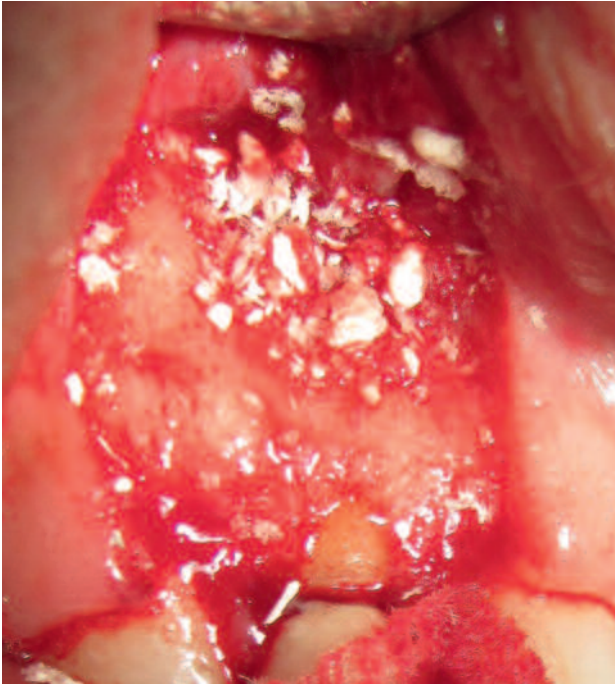
Fig. 9

We placed Genox® Org Genius-Baumer bovine liophilized bone in the cavity to fill-in the bone defect. (Fig 9)

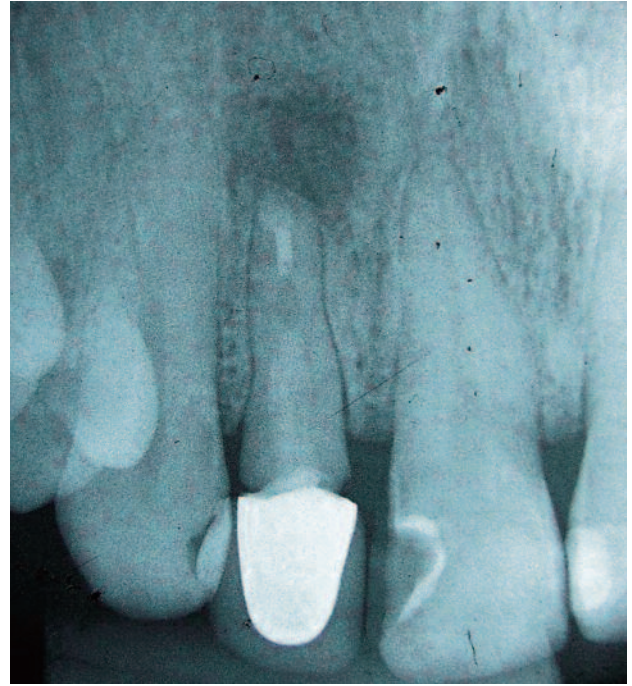
Fig. 10

We closed with 3-0 black silk suture, and treated with amoxicillin plus clavulanic acid 500 mg, every 8 hours for 7 days and ibuprofen 400 mg every 8 hours for 4 days, as well as recommending a 0.12% Chlorhexidine Gluconate mouth wash 3 times a day for 7 days. A control X-ray was taken. (Fig 10)

The disadvantage observed in the retrograde restoration was a low radiopacity of the material in comparison with amalgam, which complicates the evaluation of the quality of the obturation seal.
